Manhole Inspection Summary

Manhole # S21A__053MH

Insp Date: **10/18/07 10:35 AM**

Location Address: **603 APPLETON-MONROE**

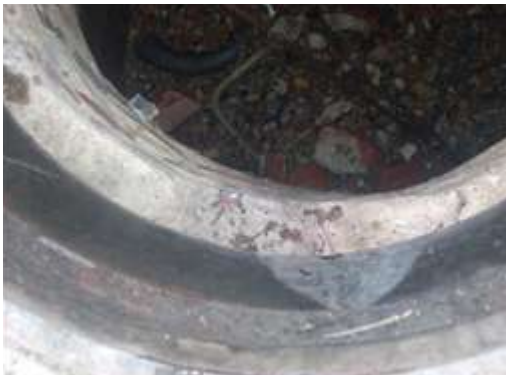
Defect 2

Offset: **2** (in.)

FRAME OFFSET

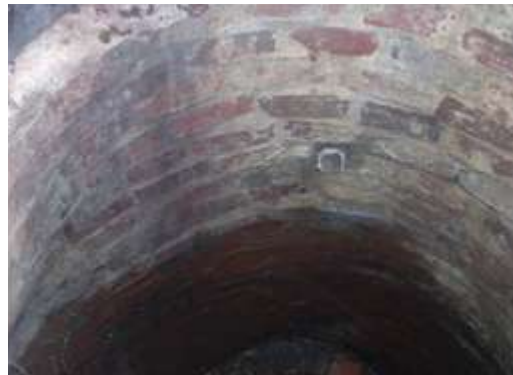
Defect 1

Infiltration: ☐ None ☒ **Joint** ☐ Cracks ☐ Mortar ☐ Roots ☐ Wall

BARREL INFILTRATION

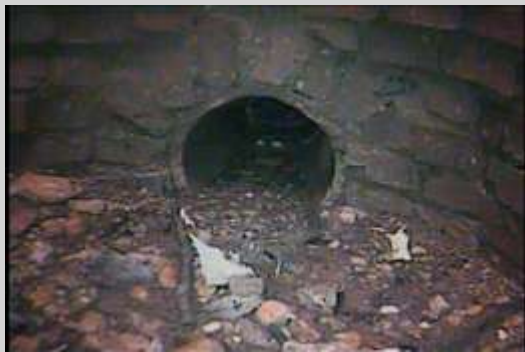
12 O'Clock Outflow

8 in. Circular Gravity Sewer
Pipe Out @ 12 O'Clock

Deposits: ☐ None ☐ Mud ☐ Sludge ☒ **Debris** ☐ Grease

Silt Depth: **1** (in.) Deposits Extent: **Light**
